Feasibility Report

FOR MELTON BOUROUGH COUNCIL

BECKMILL COURT, MELTON MOWBRAY

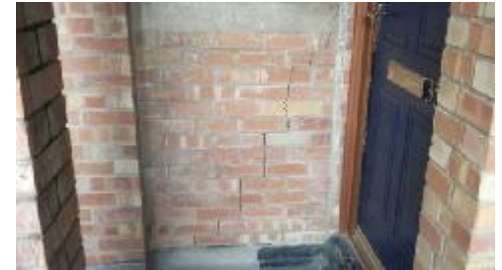
Example of vertical and diagonal cracking

- Cut out and replace frost damaged brickwork and repoint where needed.
- Remove failing lead flashing and redress.
- The diagonal and horizontal cracking should be monitored for further movement and an assessment made on its repair. If there is no further movement, the crack should be re-pointed.
- Replace existing metal framed windows and allow for new DPCs and cavity closers and jambs.
- Provide new upgraded lighting to the communal stairwells.

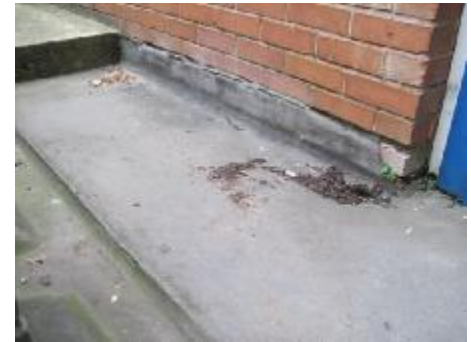
- Poor condition of mastic asphalt covering to some open balconies, including crazing of the surface and damaged up stands leading to deterioration of the underlying concrete. Replacement of all asphalt coverings are to be anticipated within the next 10 years.
- Common areas found to be poorly lit generally, including an absence of emergency lighting within stairwells.
- Full height glazed screens to communal circulation areas show no evidence of collision resistance and should be replaced with full height glazed collision resistant screens complying with building regulations.

Example of damaged and poor condition asphalt

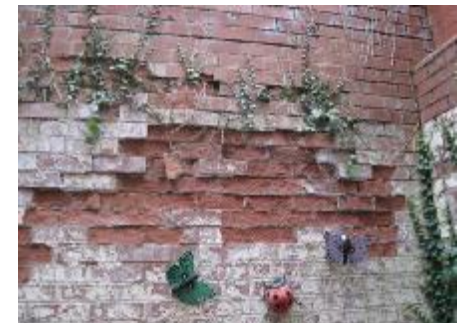
- Weathered brickwork noted to top of gable ends and around openings with numerous frost damaged bricks noted at low level beneath the DPC.
- Inadequate detailing to freestanding brickwork and parapet walls, leading to decay of mortar jointing.
- Missing lead covering and flashings noted to porch roofs at entrances to common areas.
- Vertical and diagonal cracking up to 10mm in width was noted within the common stairwell to flats 34-41 and 15-20 at the abutment between the stairwell and the adjoining building.
- Failed / failing and ill-fitting metal window casements where not previously replaced by u-PVC units, including blown gasket seals. DPC may also be missing or absent from sill level, contributing to the deterioration of brickwork below.

Example of weathered brickwork

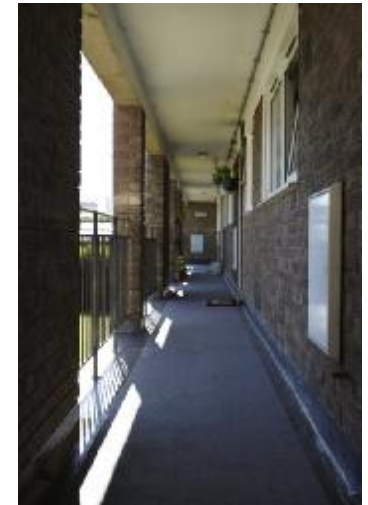
The existing asphalt walkways are approaching the end of their economic life and replacement has been considered and costed within this report. A like-for-like finish has been allowed for within this report.

Example of asphalt walkway

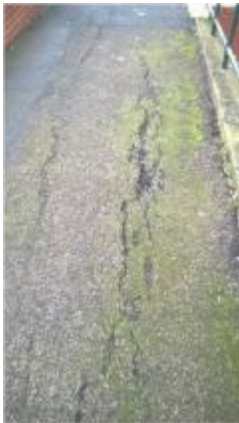
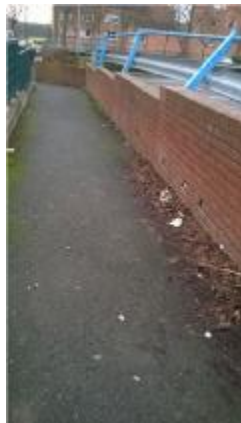
Improvements to the worn tarmac footpath to the rear of the site, seen below, are proposed in conjunction with the possible replacement of existing frost damaged steps and aged steel handrails. It is suggested that new powder coated steel handrails are installed along with Marshalls 'step' pavers. There is also need for an analysis of site access routes with a view to rationalising them. This will reduce the number of 'dark corners' currently to be found within the scheme and can also rationalise the routes that non-residents take through the scheme.

Existing poor condition hard landscaping

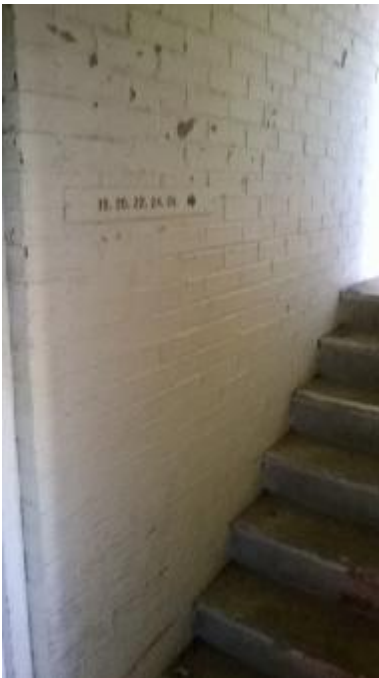
The existing internal communal areas have poor decorations and add to the tired and cold feel of the building, see below left. With the proposed external upgrade works improving the appeal of the scheme from the exterior, it is suggested that the internal areas are upgraded at the same time. Works have therefore been designed to improve the appearance of the communal stairwell areas and make them more welcoming to residents. It is proposed these works consist of:

- Redecoration of existing painted brick walls.
- Redecoration of existing painted concrete ceiling soffit.
- Installation of proprietary pre-finished stair nosing.
- Removal of existing top floor ceiling under boarding and renewal with alternative decorative boarding.
- Installation of additional conduit trunking to tidy up existing cables.
