Feasibility Report

FOR MELTON BOROUGH COUNCIL

GRANBY HOUSE, MELTON MOWBRAY

February 2015

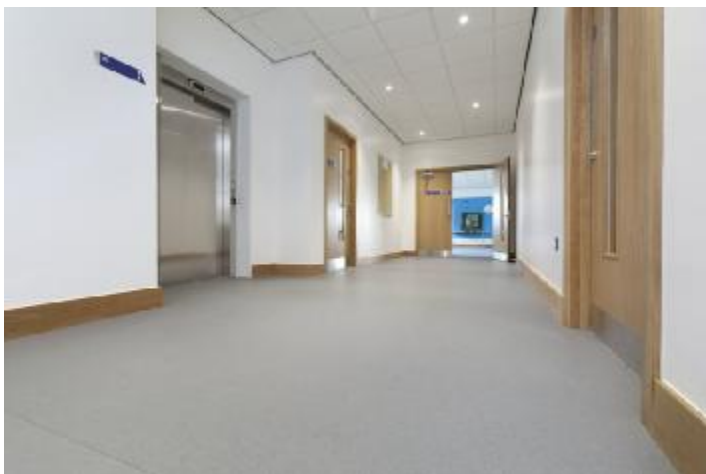
Two options have been considered to address the existing thermoplastic floor tiles, seen adjacent, with the aim of improving their appearance and giving a more comfortable feel underfoot;

- Flooring Option A – Installation of anti-slip vinyl (see below)
- Flooring Option B – Installation of carpet tiles

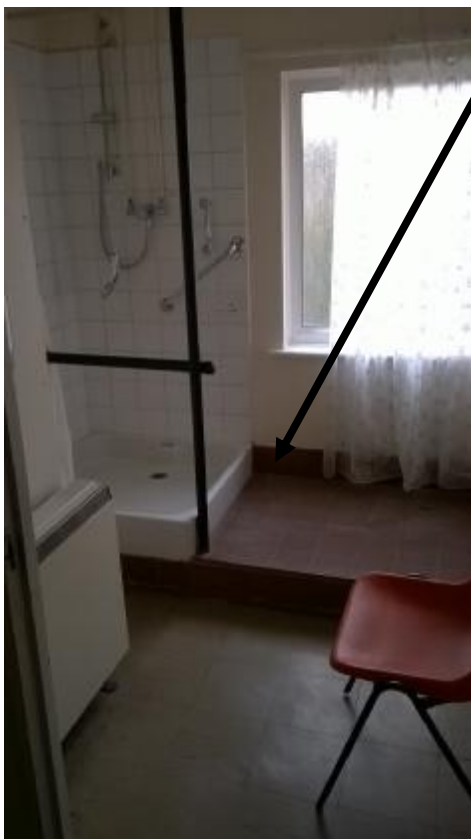
Barrier to access to shower created by tiled boxing and a high step into the shower tray.

- Stripping out existing sanitary ware.
- Installing new vinyl flooring.
- Installing Whiterock walls to the shower room and partially tiled walls the bathroom.
- New lighting.
- New wash hand basins including grab rails.
- New disabled access shower including grab rails (see photo).
- New disabled access bath including grab rails.
- New wider disabled access doors.

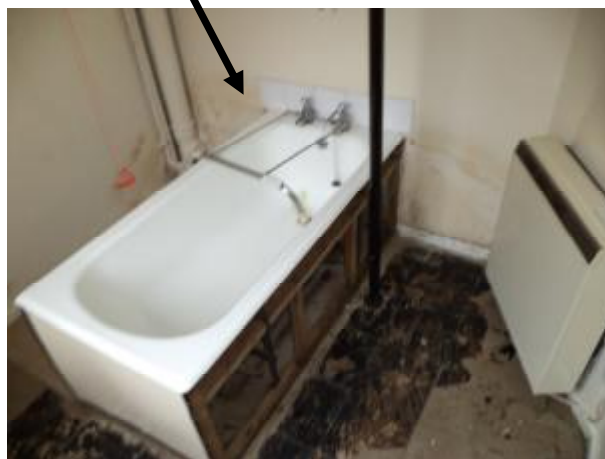
The poor condition of the sanitary ware and existing floor tiles as seen below has led to the disuse of the facilities, increasing the risk of legionella.

The potential risk associated with leaving the bathrooms in their existing state will promote the growth of legionella through the stagnant water within the pipework caused by lack of use. This contamination can spread into the remainder of the buildings water supply system, potentially affecting the residents who are of an elderly age within Granby House and so are a particularly vulnerable population. It should be noted that regardless of the development route taken, all bathing facilities not in use should be decommissioned to mitigate the risk of this.

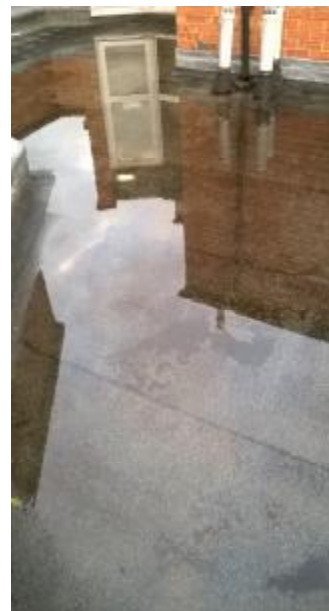
Both roofs are holding large volumes of ponded water, image below. The following reasons for this were observed:

- Insufficient number of roof drainage outlets for the area of roof being drained.
- Water from local pitched roof draining onto flat roofs further increasing volume of water and overwhelming roof drainage.
- Roof outlets surrounded by soil stacks. The collars of the soil stack are higher than the roof deck which is restricting drainage into the outlets.
- Walkway tiles have been installed directly to the roof deck. There is no provision for water to drain under the tiles and these are further preventing water entering the roof drainage.
- A metal handrail has been installed to the rear elevation flat roof. This is fixed into concrete blocks which have been laid directly onto the roof deck. The extra weight of this may be causing deflection of the roof deck so further preventing the water draining into the outlets.

There was evidence that the up stands are also beginning to fail with pointing missing to the lead flashings covering the up stands. This was particularly evident to the roof overlooking the Greenslade elevation.

There are areas where the mineral felt surface layer is observed to have blistered. It is suggested that the mineral felt layer was installed over the original asphalt due to failures in this roof covering. The blistered areas may correspond to original defects within the asphalt or areas where the mineral felt has not fully bonded to the asphalt.

These flat roofs are in poor condition with inadequate drainage and the large volume of ponding water will only further increase the risk of leaks.

It will be necessary to affect repairs to these flat roofs to ensure they continue to perform adequately. Unfortunately it is not considered practical to increase the number of in-roof drainage outlets within this occupied building. However the potential works have been broken down into three separate options based on a short, medium and long term option:

Due to the presence of a fire escape route across this flat roof it is considered especially important to reduce incidents of water ponding with the risk of it freezing and becoming a slip hazard. It is therefore recommended that the long term repair option is considered as the most suitable option for this roof.
