Feasibility Report

FOR MELTON BOROUGH COUNCIL

GRANBY HOUSE, MELTON MOWBRAY

February 2015

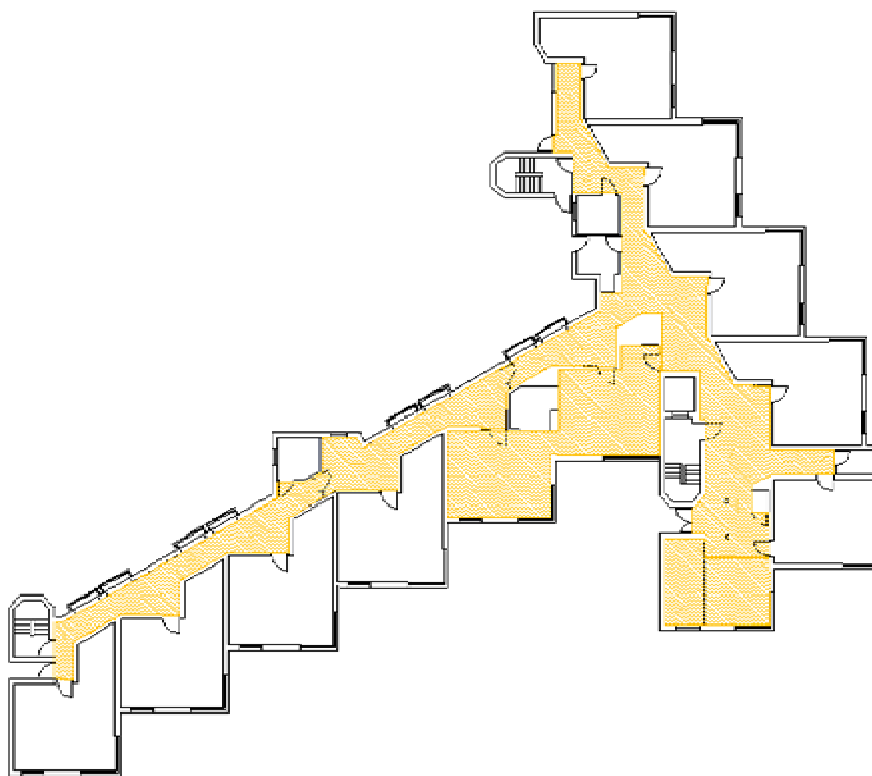
Ground Floor Plan

A number of different options are outlined below which have been designed to address the issues within the circulation spaces highlighted on the drawing below.

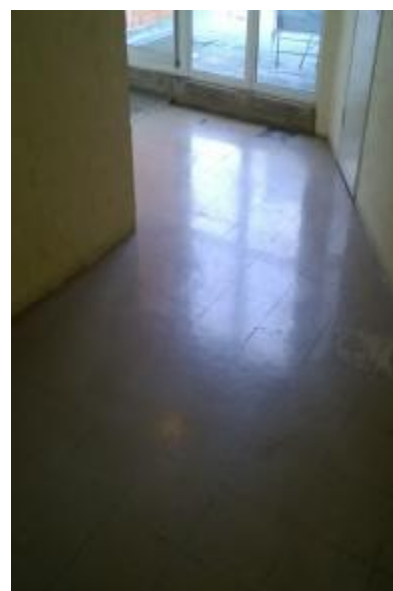
Two options have been considered to address the existing thermoplastic floor tiles, seen adjacent, with the aim of improving their appearance and giving a more comfortable feel underfoot;

- Flooring Option A – Installation of anti-slip vinyl (see below)
- Flooring Option B – Installation of carpet tiles

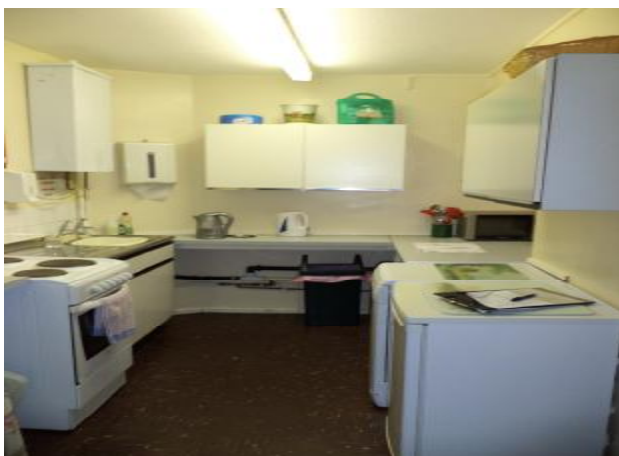
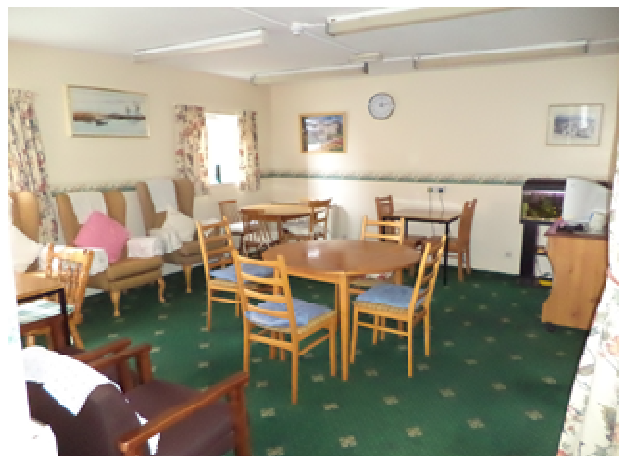
- There is a lack of storage space
- The residents would benefit from having increased worktop space
- The existing dining room is not inviting

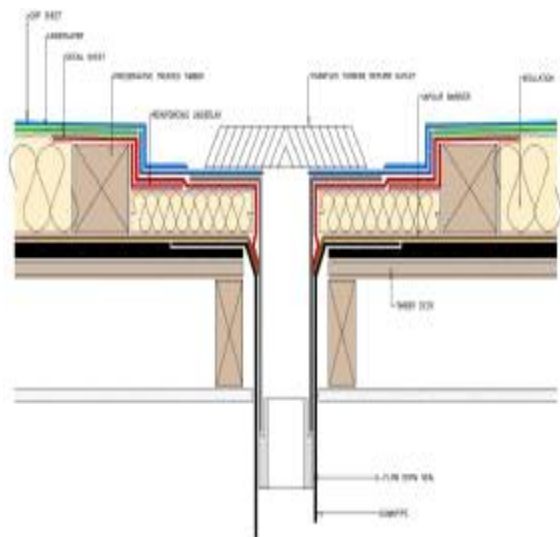
covering. In addition any underlying defects in the asphalt roof covering will not be corrected. It is likely that the existing asphalt will be in poor condition given previous decisions to overlay with felt.

As part of the works the profile of the roof will be modified to attempt to improve the drainage of water from the roof into the outlets. However as the new roof covering is being laid over the existing roof the extent to which this can be done will be restricted by the profile and thickness of the existing asphalt roof
